1,050MW Coal Fired Power Plant Ecological Impact Assessment Study

Amu Power Company Limited

Report No. KT/4085/ESIA/V1/R1

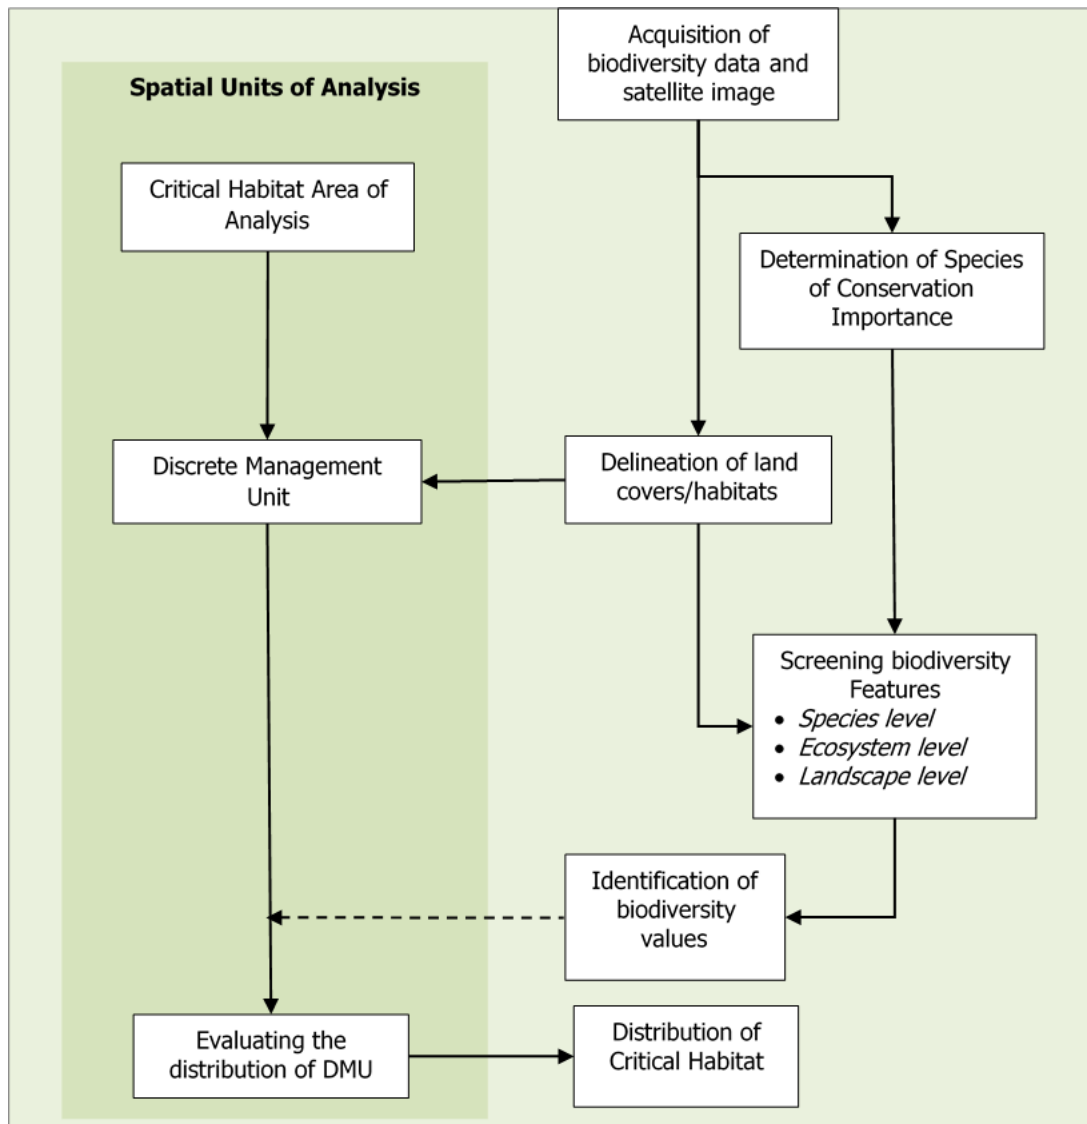
Figure 3-1: summary of the process of delineating critical habitats

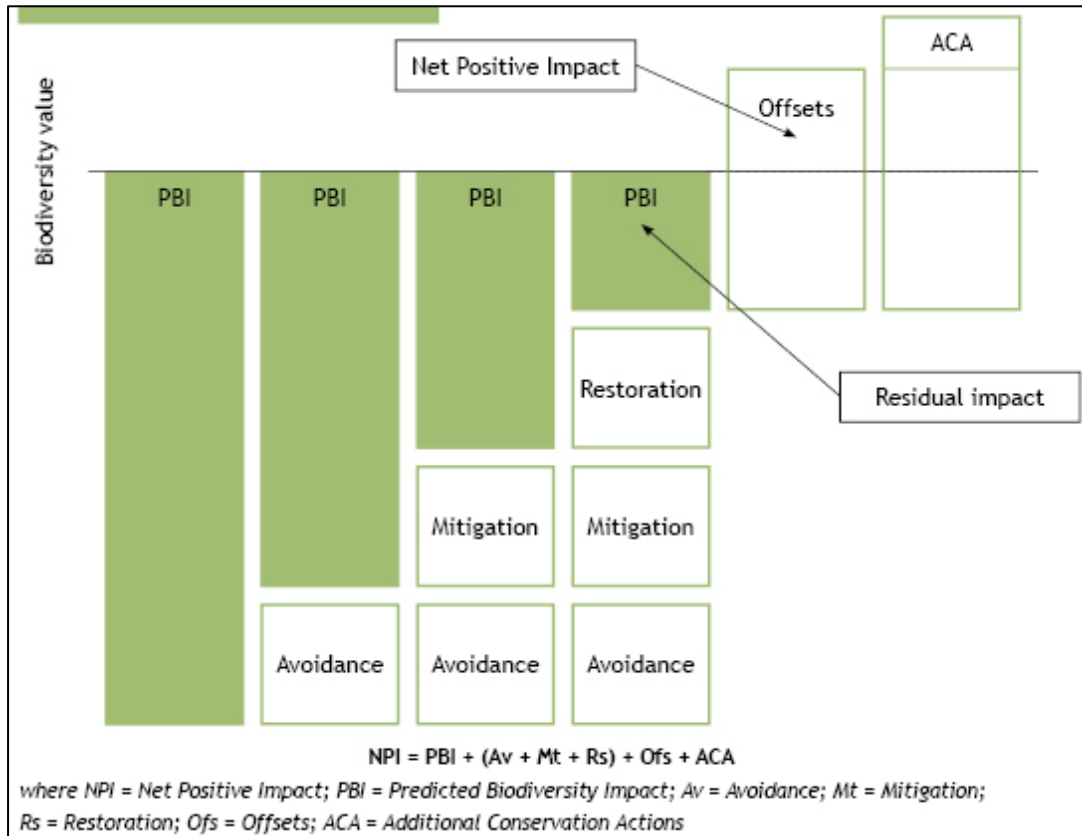
Figure 4-1: Mitigation hierarchy adopted for ecological impact assessment
